# **FABRICATION AND VERIFICATION TESTING OF ETM 30 CM DIAMETER ION THRUSTERS**

**FINAL REPORT**

**ION PHYSICS DEPARTMENT STAFF  
HUGHES RESEARCH LABORATORIES  
A DIVISION OF HUGHES AIRCRAFT COMPANY  
3011 MALIBU CANYON ROAD  
MALIBU, CALIFORNIA 90265**

**CONTRACT NAS 3-17803  
JAMES S. SOVEY, PROGRAM MANAGER**

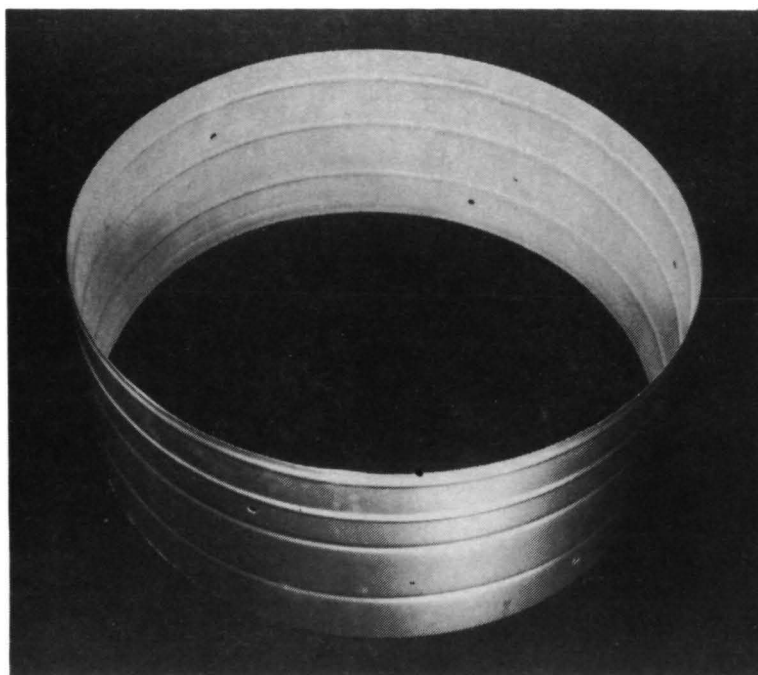
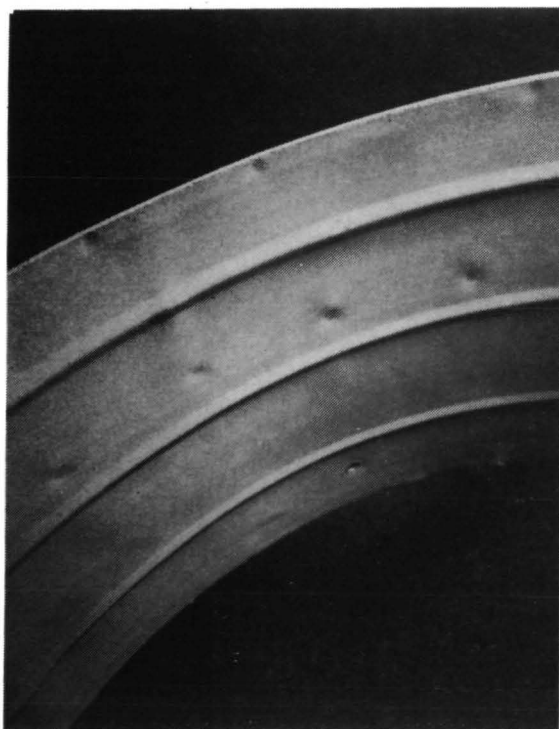
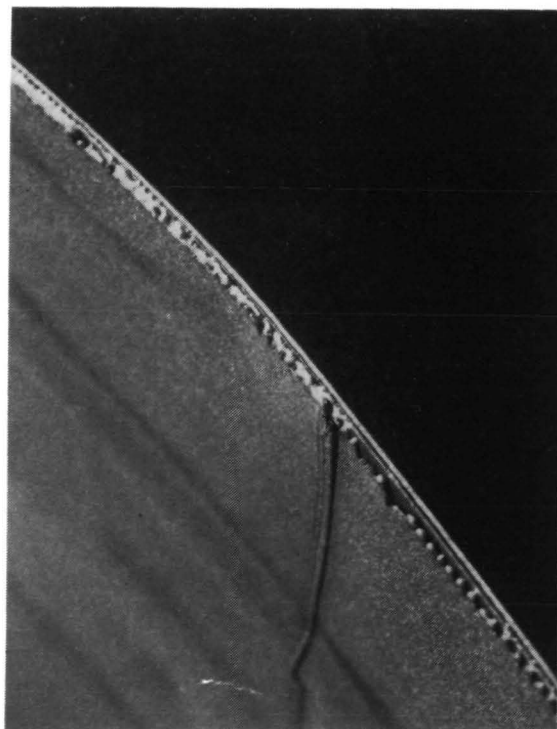
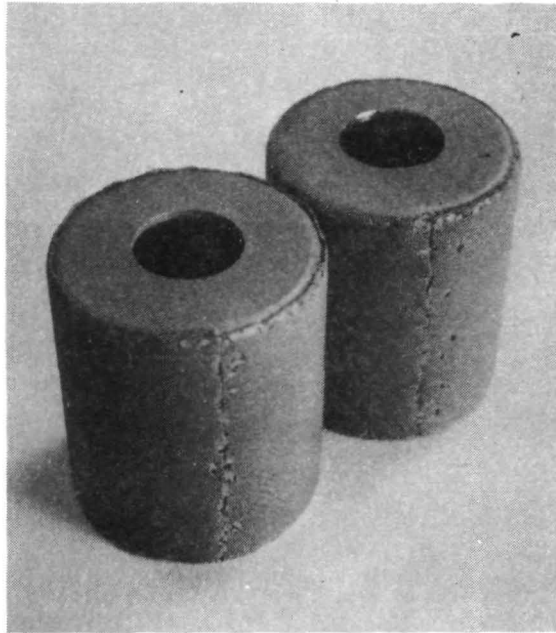
Figure 27. Discharge chamber surfaces covered with stainless-steel mesh to reduce spalling.

deposited. This can be done in two ways: grit blasting and covering the surface with a fine stainless-steel wire mesh. Both techniques were used in the 900-series thruster. Table 7 itemizes the sites where these flake-control methods were applied within the discharge chamber. Figure 27 illustrates how the stainless-steel mesh was added to various components.

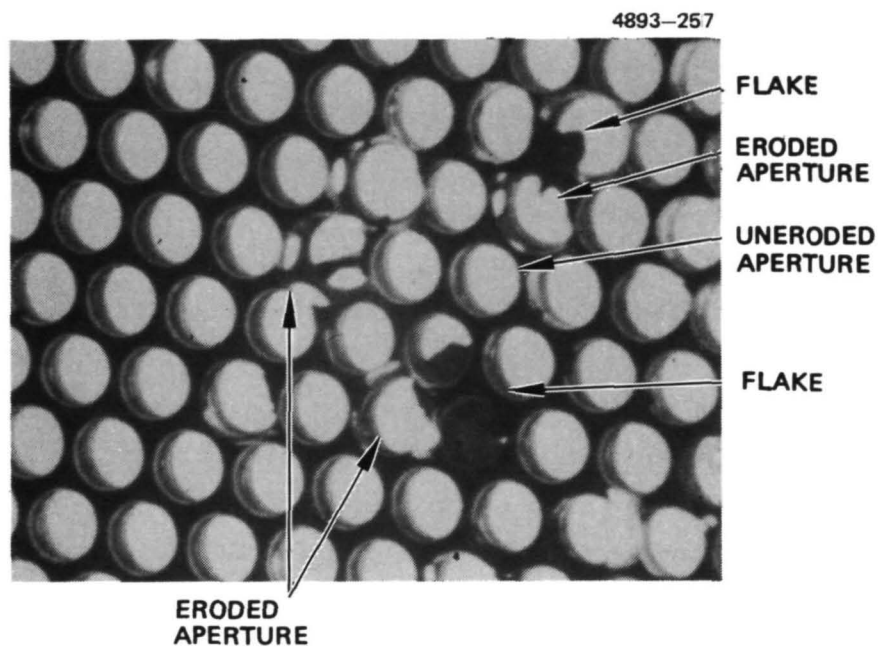
Figure 32. Photograph of optics showing flakes on screen electrode and localized erosion of accelerator electrode apertures caused by flakes. (Accelerator aperture diameter is 0.15 cm.)

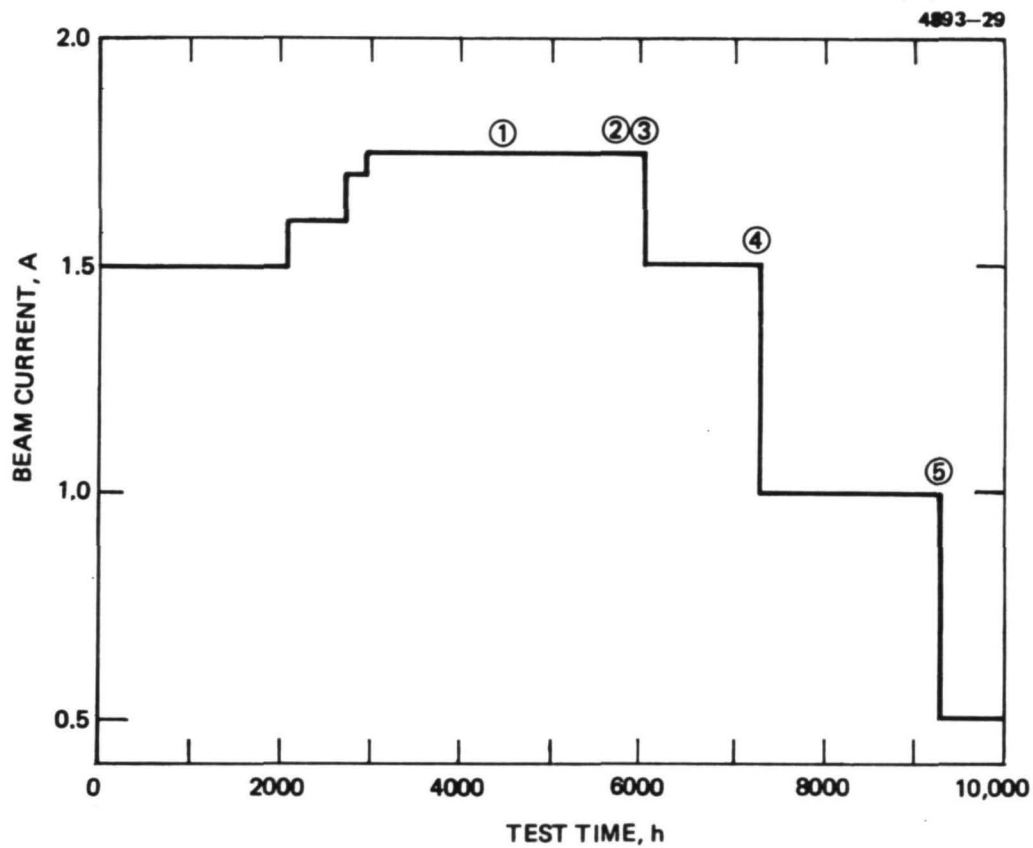
- ① FLAKES ON OPTICS AT HOUR 4530
- ② HOLE IN BAFFLE AT HOUR 5845
- ③ HIGH TRIP RATE DUE TO FLAKES
- ④ LOW DISCHARGE VOLTAGE MODE DUE TO ERODED BAFFLE
- ⑤ HIGH TRIP RATE DUE TO FLAKES AND ERODED BAFFLE

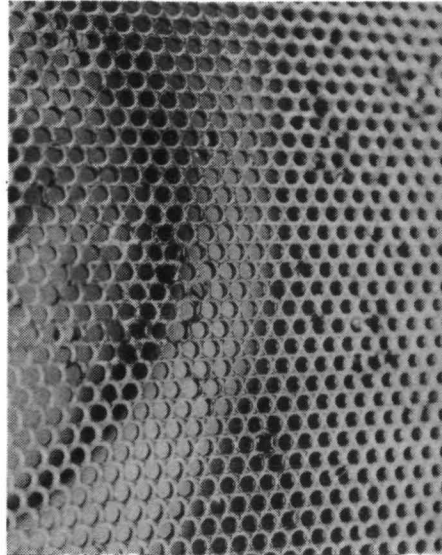
(c) DAMAGE TO ACCELERATOR  
APERTURES

Figure A-3. (a) Deposition on downstream surface of outer case mask. (b) Deposition on neutralizer SN 415. (c) Damage to accelerator apertures.

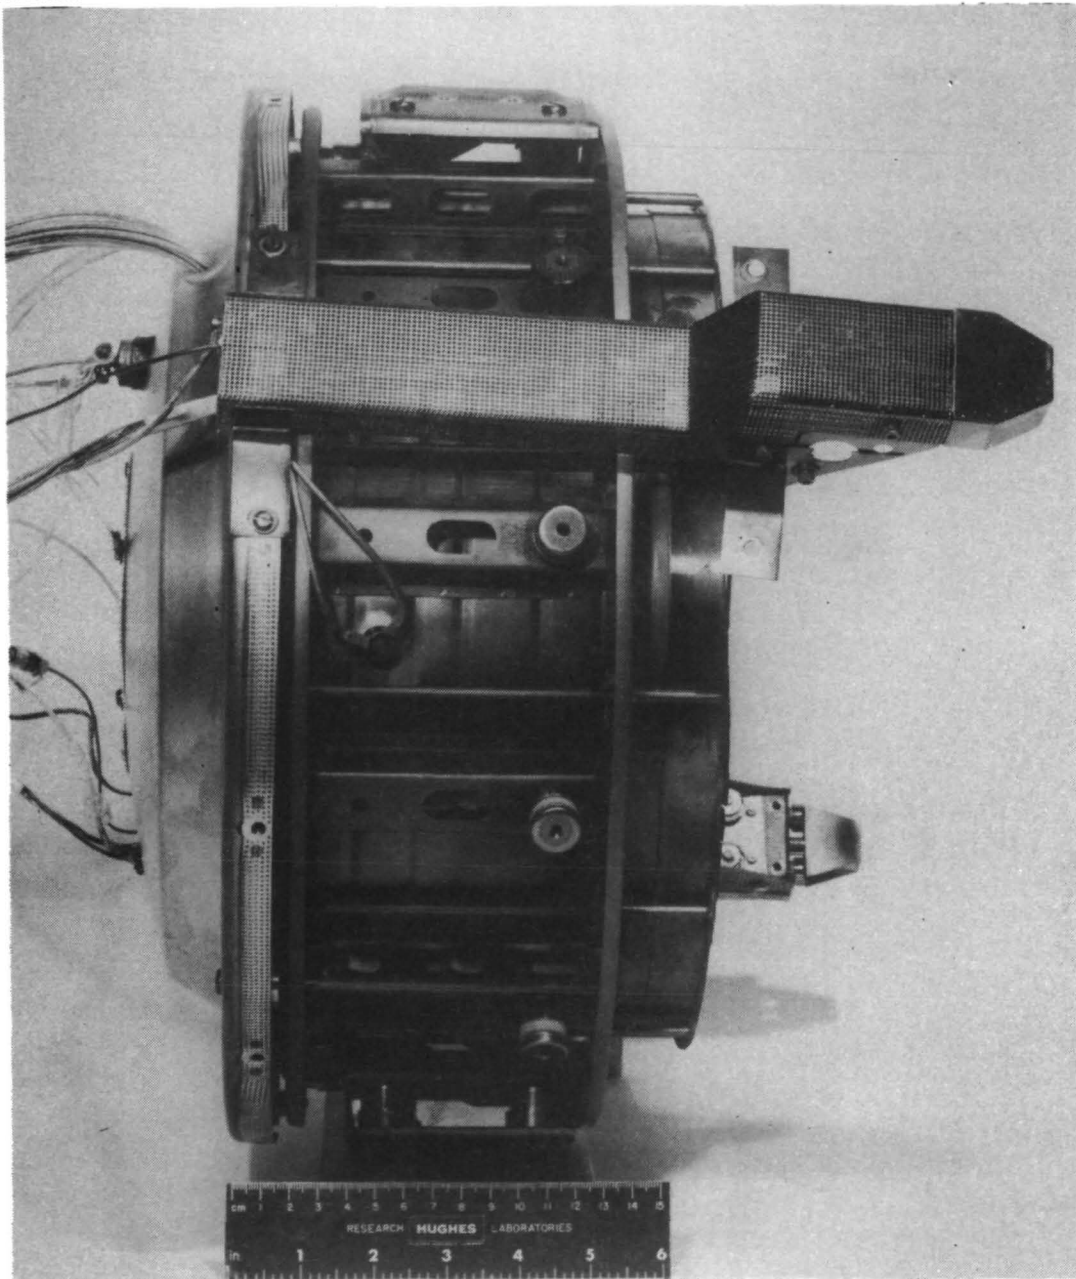
Figure A-6 is a side view of the thruster and two observations are noteworthy. First, it can be seen that two of the insulators used to support the outer case have the "shadow shields" removed, exposing the ceramic surfaces. These insulators showed no electrical leakage and the ceramic surfaces are clean and free of any discoloration. Second, on the discharge chamber shell adjacent to the anode terminal seen in the center of the photograph (arrow) a "bright" region can be seen on the metal where the insulator makes contact, surrounded by a darker region. The anode insulator leakage resistance mentioned earlier was a consequence of damage to this and one other anode support insulator. This damage will be discussed in detail in the discharge chamber section with reference made to the coloration noted here. Figure A-7 shows the opposite side of the thruster. The fracture seen in the cover on neutralizer SN 701 is considered a weakness of the prototype cover and support design and a design change has already been incorporated in thruster SN 702A.

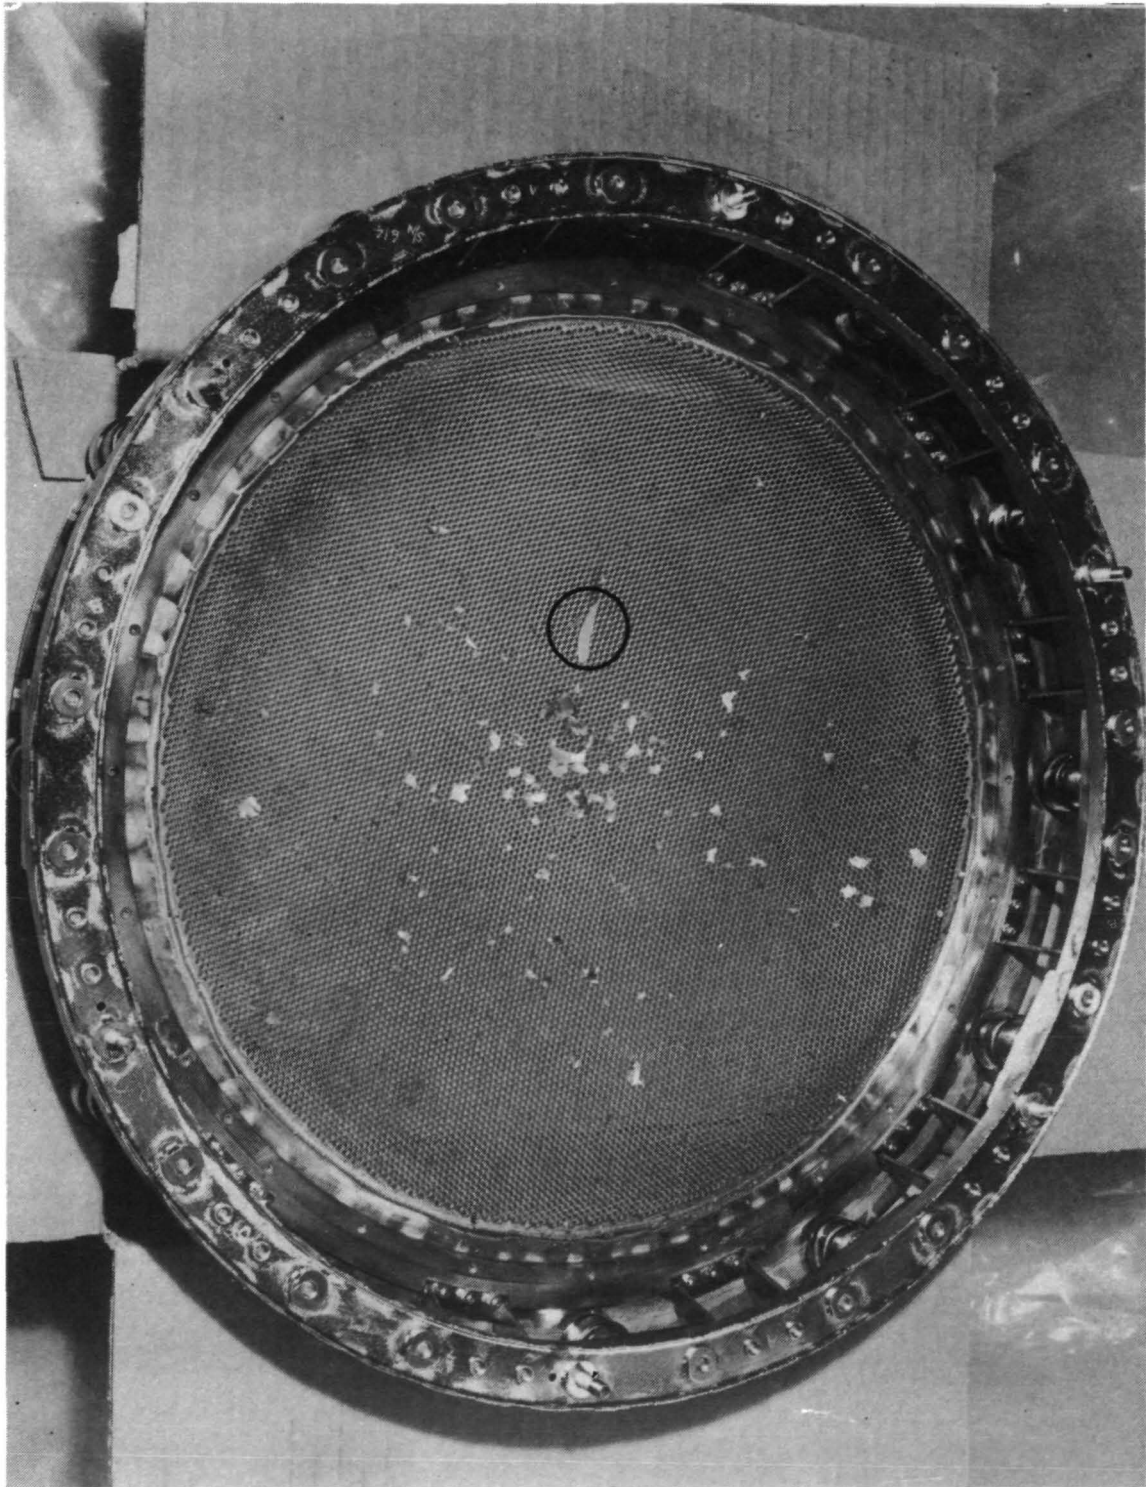
Figure A-12. Optics with flakes on upstream side of screen electrode. Encircled flake is piece of baffle.

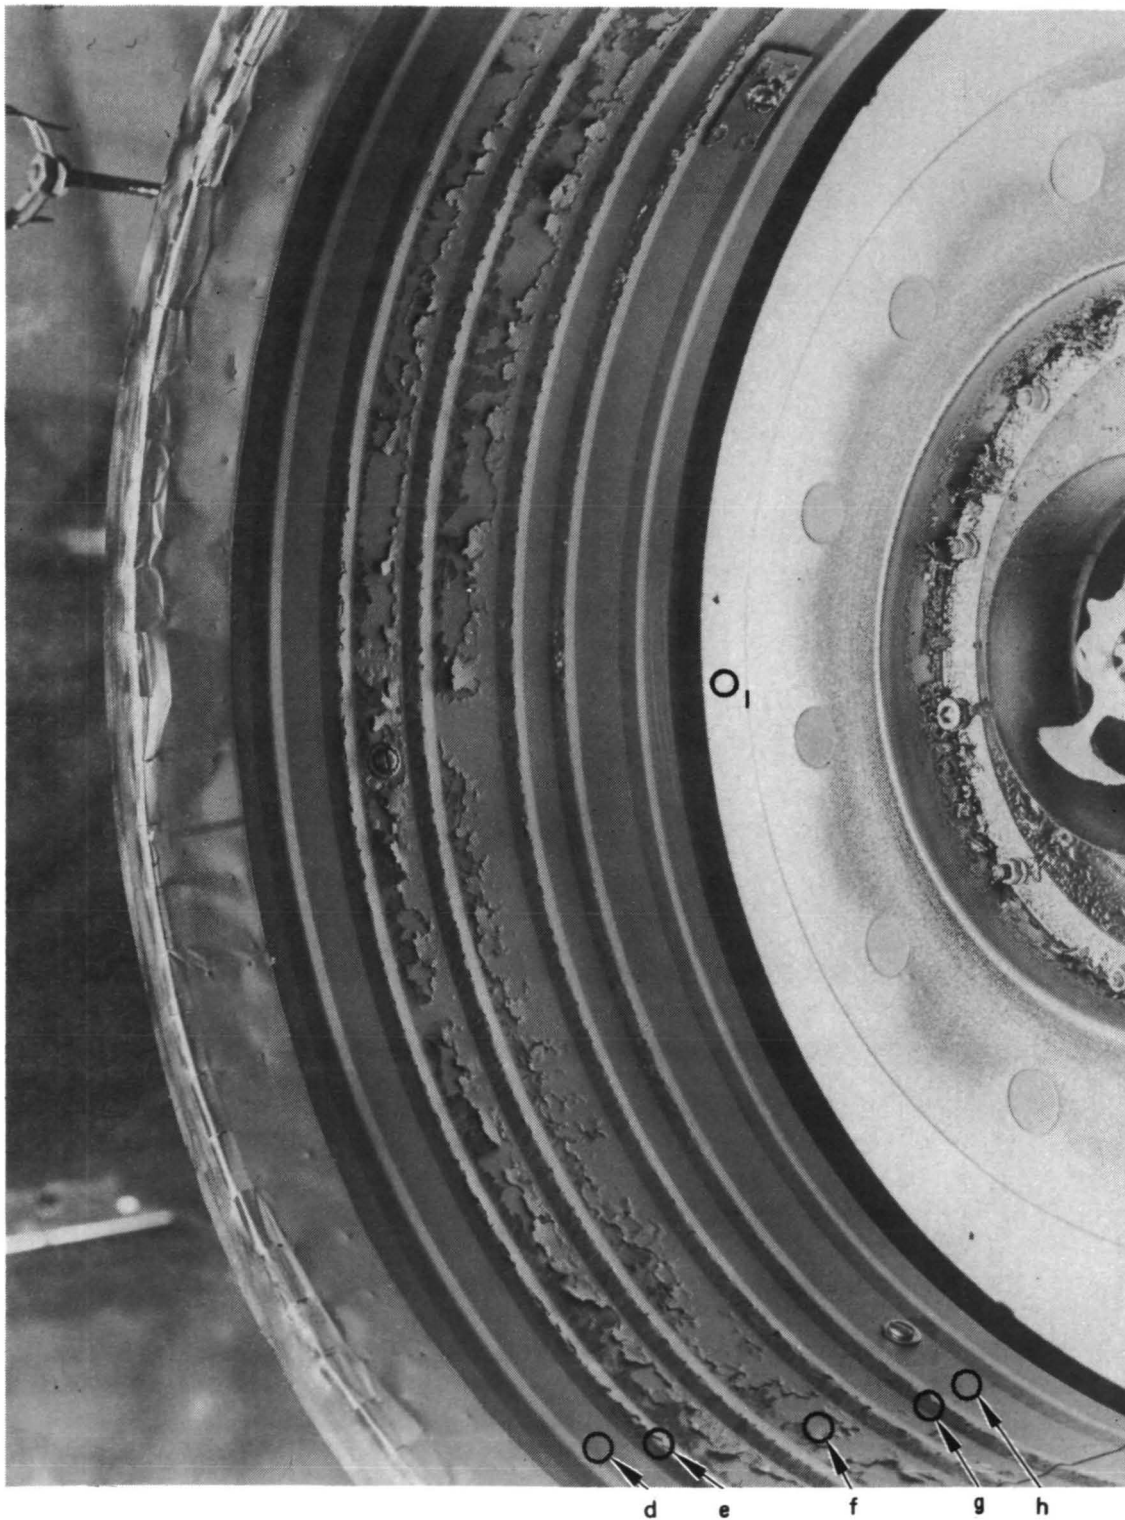
Figure A-16. Sputter deposition on anode.

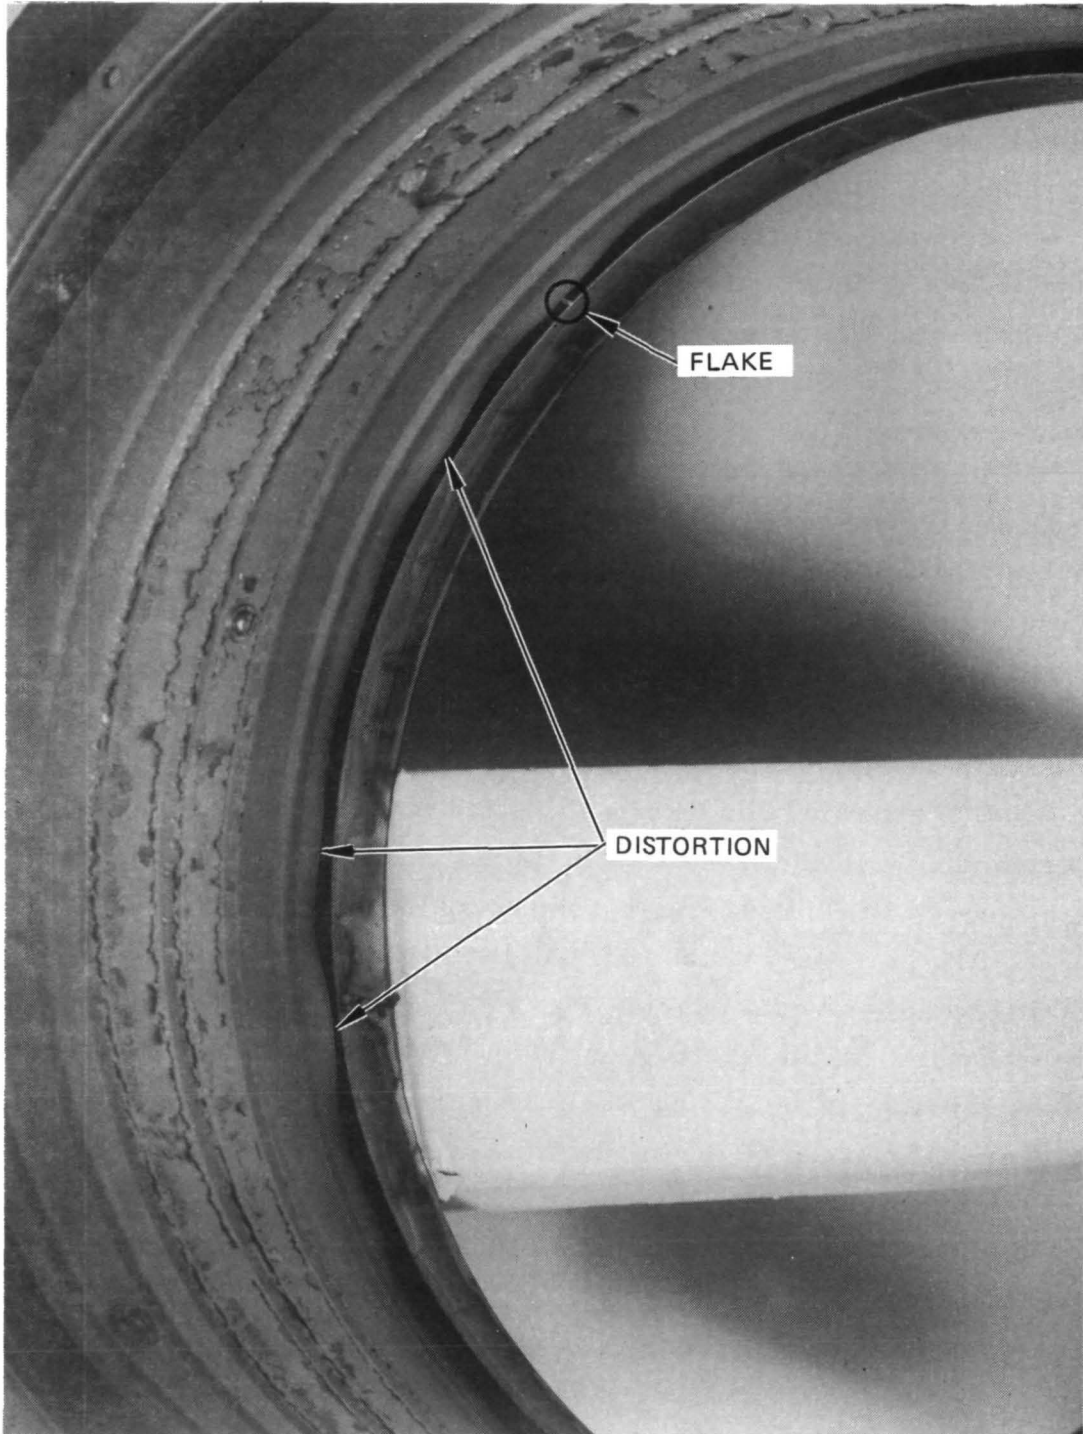
Figure A-20. Part of anode showing distortion and flake.

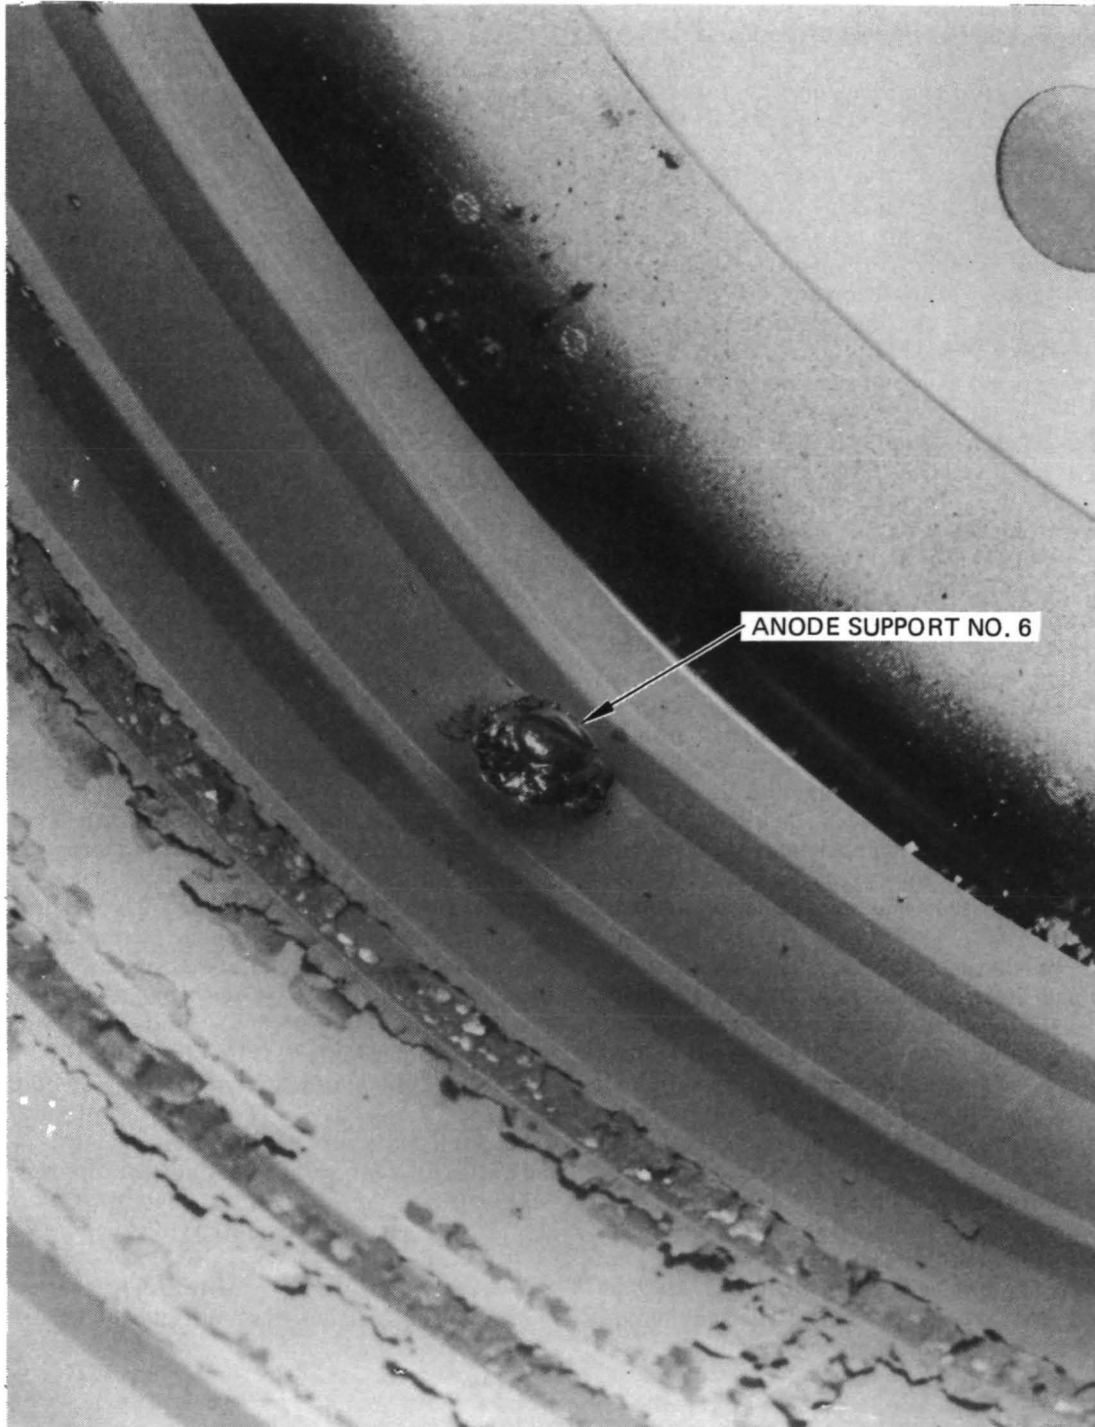
An interaction between the anode and the anode fasteners can be seen on two of the six fasteners which hold the anode in place. The anode supports numbered 1, 3, and 5 were nearer the downstream end of the discharge chamber, while numbers 2, 4, and 6 were located nearer the upstream end. Enlarged photographs of these two fasteners are shown in Figs. A-21 and A-22 (which will be referred to as anode support numbers 6 and 2, respectively). The stainless steel screw of anode

Figure A-21. Part of anode showing damaged anode support No. 6.

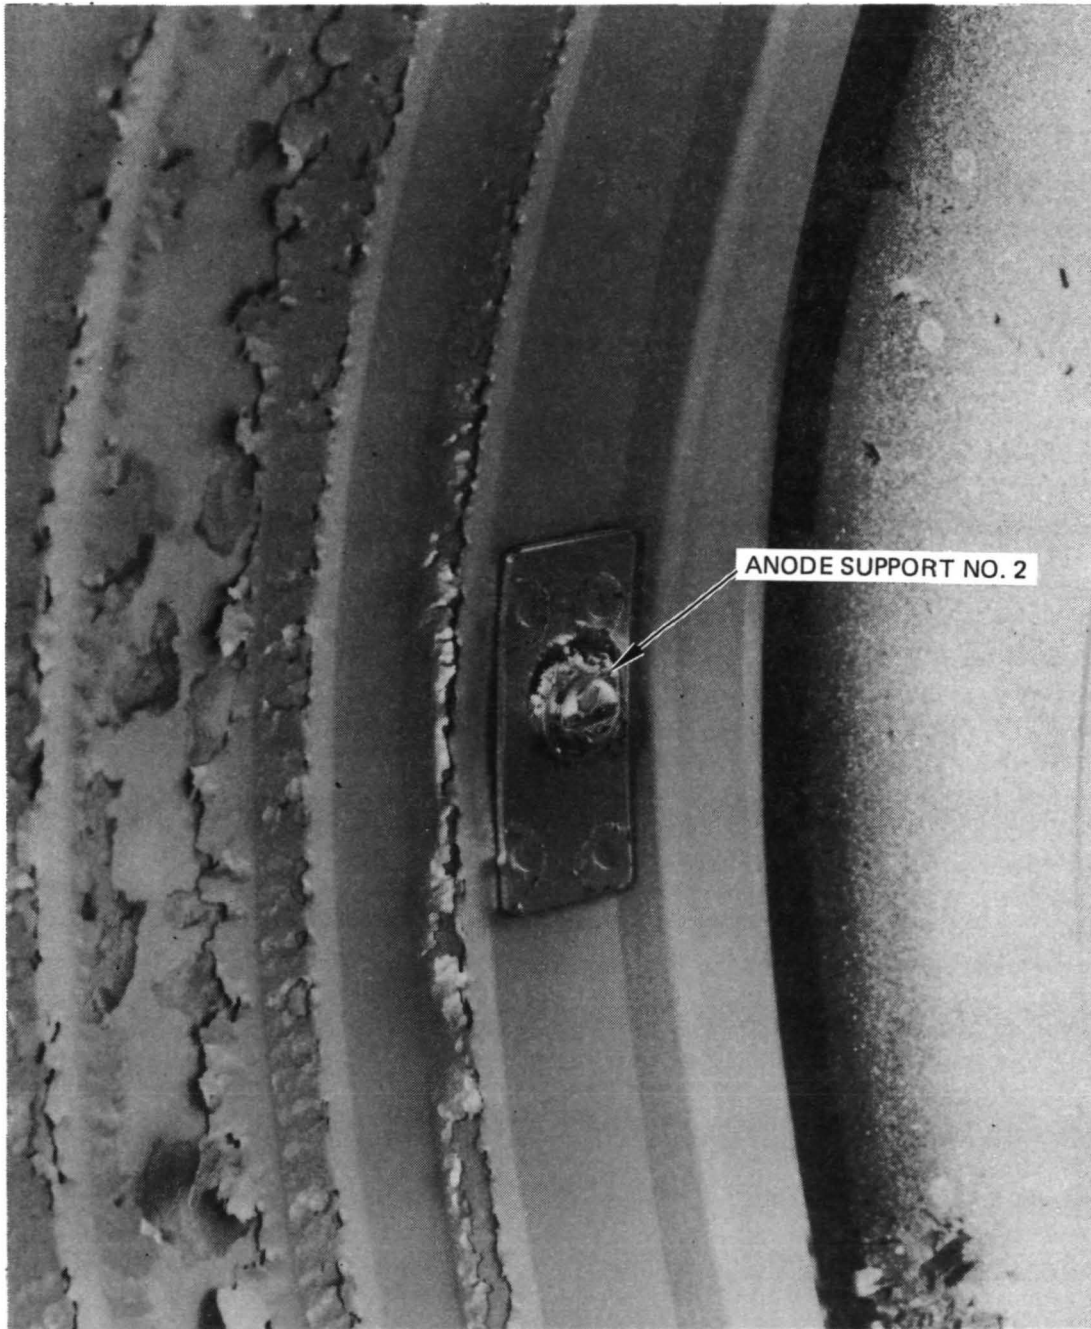
Figure A-22. Part of anode showing damaged anode support No. 2.

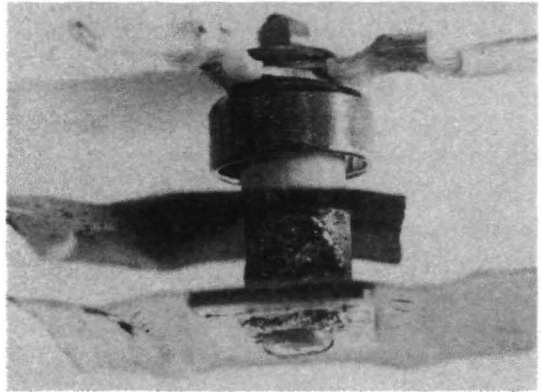
Figure A-25. Damaged anode support No. 2.

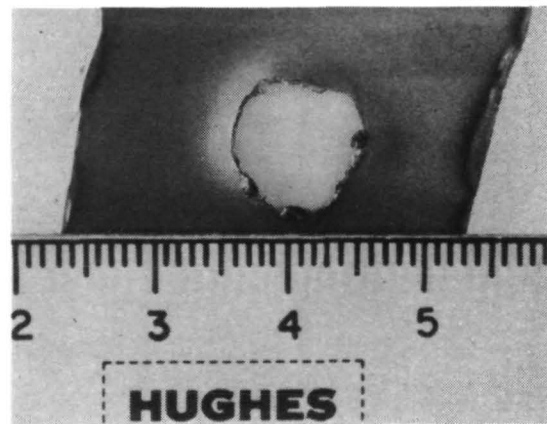
Figure A-26. Damaged anode support No. 6.

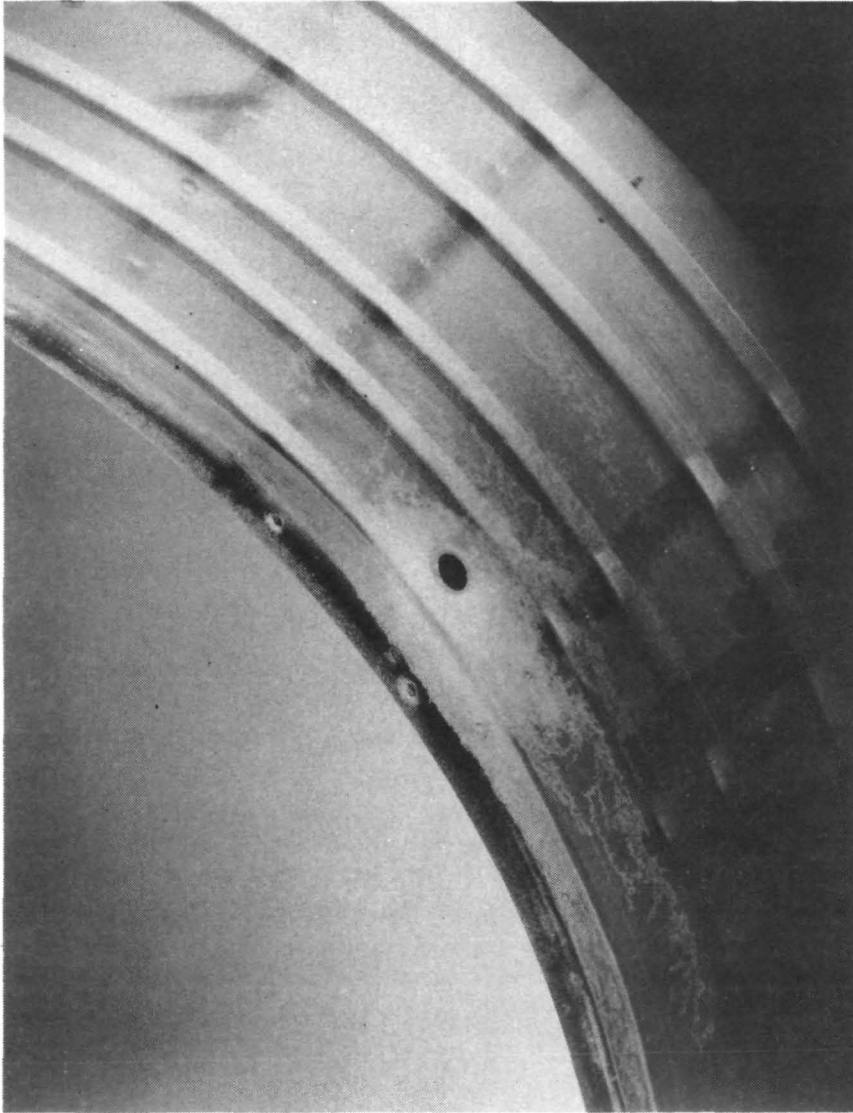
Figure A-28. Part of anode showing "arc tracks" around location of anode support.

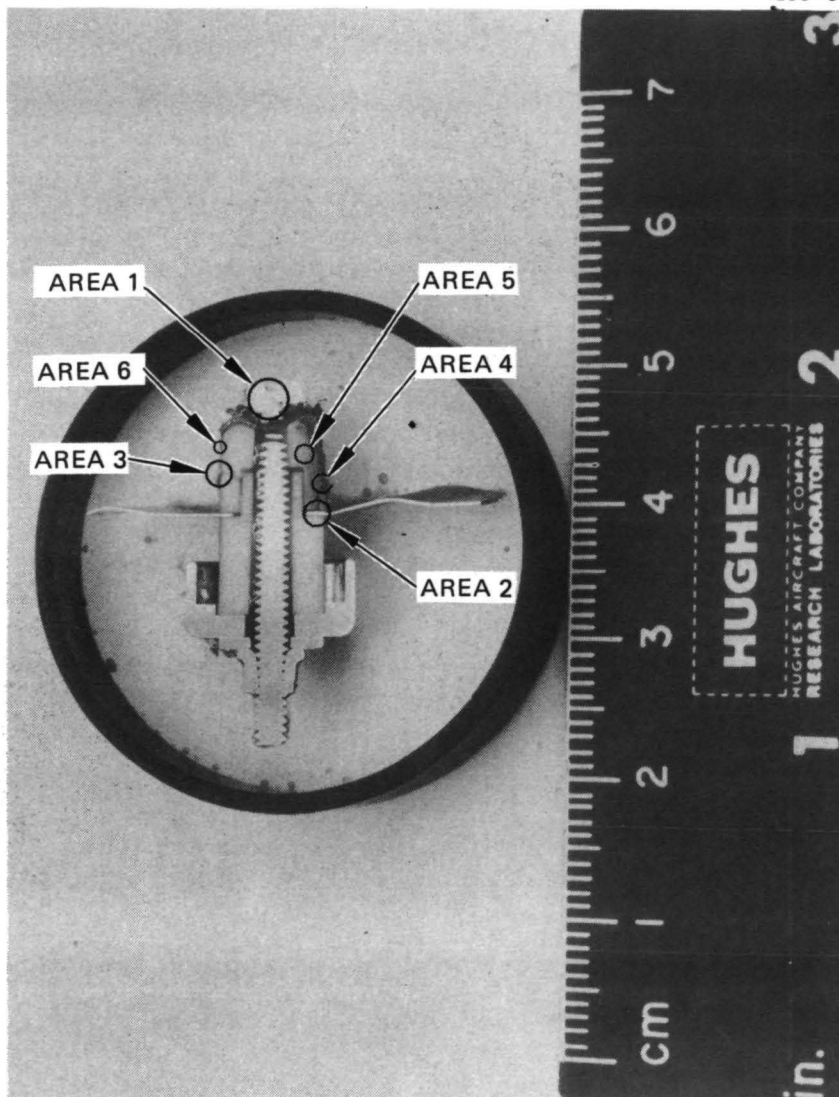
Figure A-31. Cross section of damaged anode support.

The damage to the anode support insulators is concluded to be a melting or fusion of the  $\text{Al}_2\text{O}_3$  insulator, the Ti anode, and the stainless steel machine screw. On the basis of the observable evidence, the only logical explanation of this melting is that local high temperature produces some alloying of the Ti and Al to form a moderately low temperature eutectic ( $\sim 600^\circ$  to  $800^\circ\text{C}$ ). On the basis of the "arc tracks" visible on the thruster shell, formation of a vacuum arc breakdown in the vicinity of the insulator seems to be the best explanation which can be offered for generation of these temperatures. Except for the coating seen on the insulator surface, there does not appear to be any deterioration of the bulk material. Because of the relatively low voltage applied to the anode, formation of an arc by the discharge supply might be considered unlikely, unless the applied voltage appears across a very small gap. This condition could be established if a conductive coating covered the entire anode support insulator except for a small gap between the anode and the insulator as shown in Fig. A-40. The coating and gap are shown on an exaggerated scale to illustrate the conjecture being developed here. The insulator surface would most probably charge to thruster shell potential because the thruster shell is clamped firmly between two mating

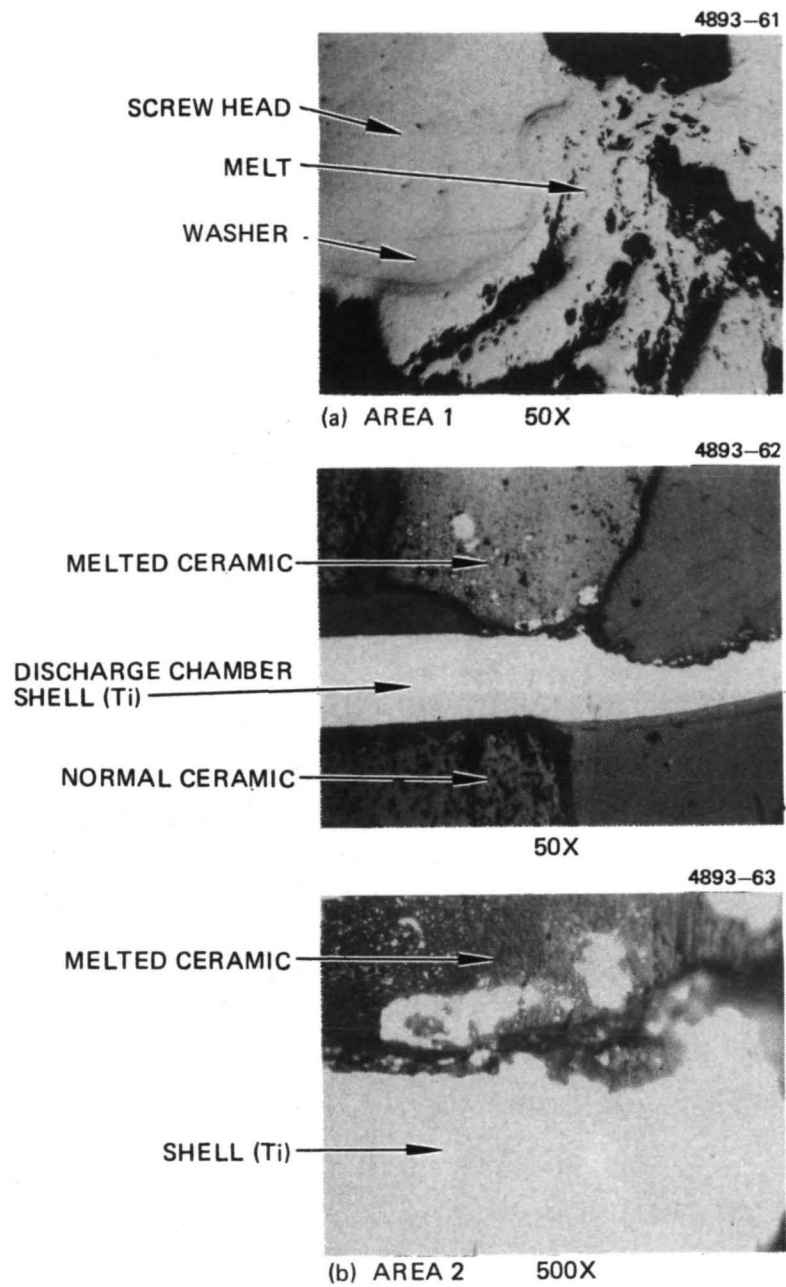
Figure A-33. Magnified view of damaged areas of anode support.

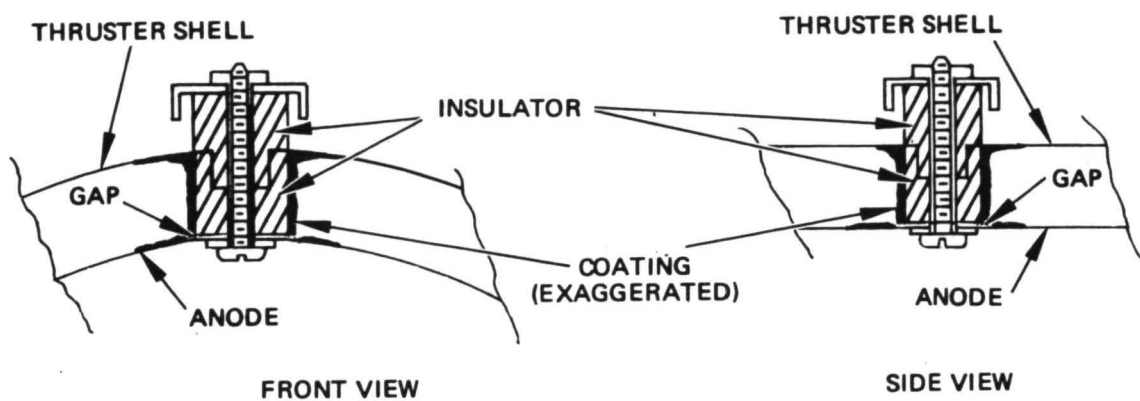
Figure A-40. Drawing illustrating possible explanation of cause of anode support damage.

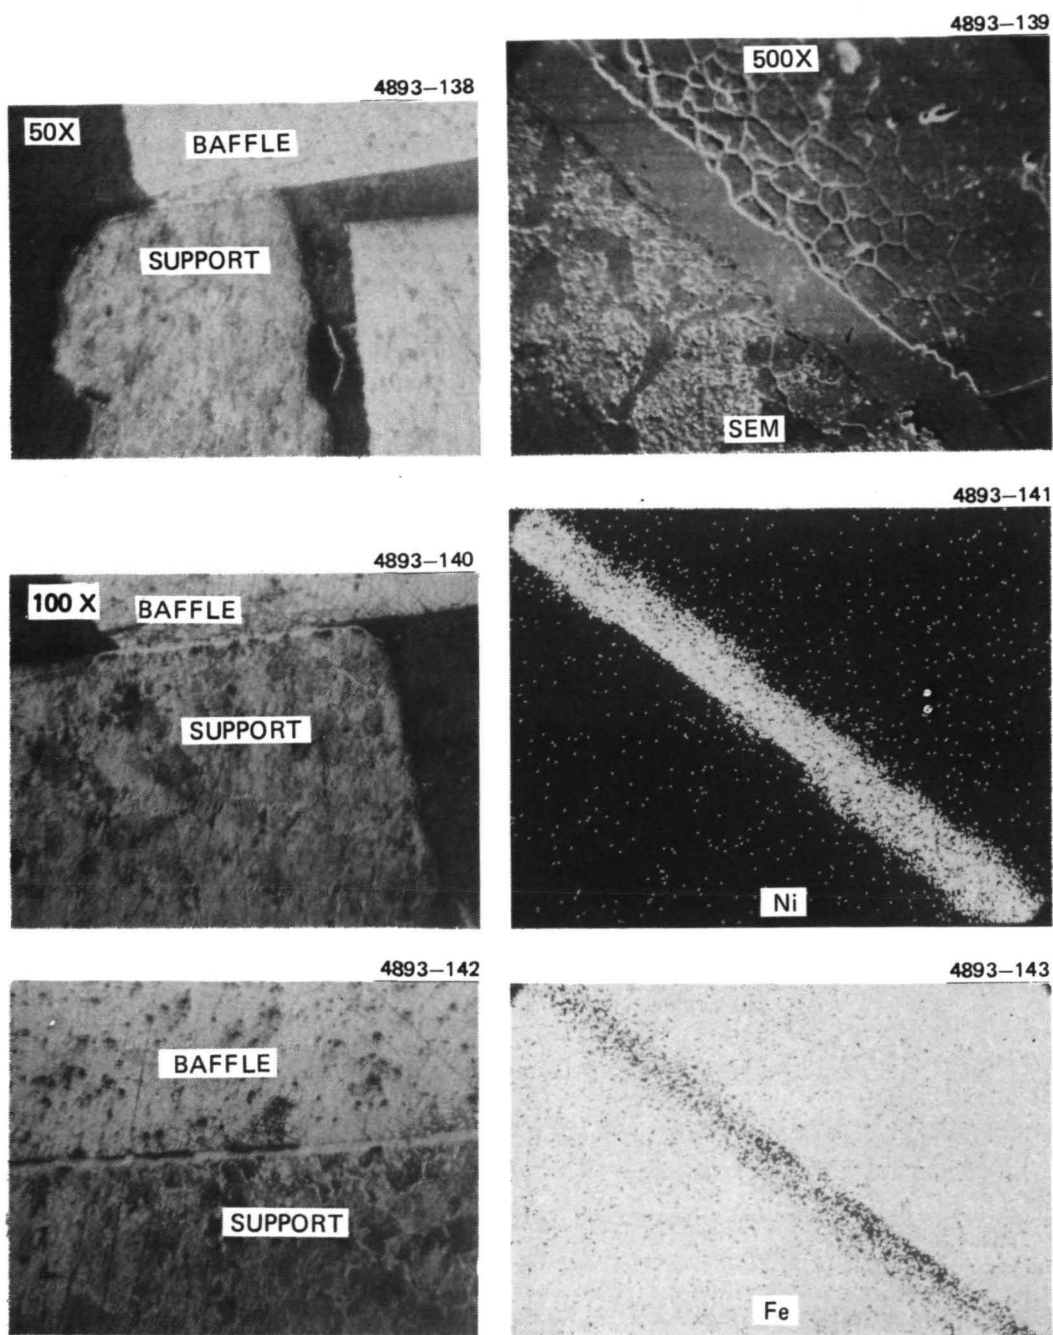
Having documented the support structure in this manner, a second attempt at removing the baffle fastening screws proved successful, but the baffle still could not be removed and was found to be securely "welded" in place. The assembly was then sectioned as shown in Fig. A-53, and the "welded" region was identified as a nickel "brazed" by means of the E-beam microprobe analysis shown in Fig. A-54. It is thought that the nickel coating placed on the mild steel parts to prevent oxidation is responsible for the "welding" of these parts. It is

Figure A-54. SEM photo and electron beam microprobe analysis of "welded" region of baffle support.

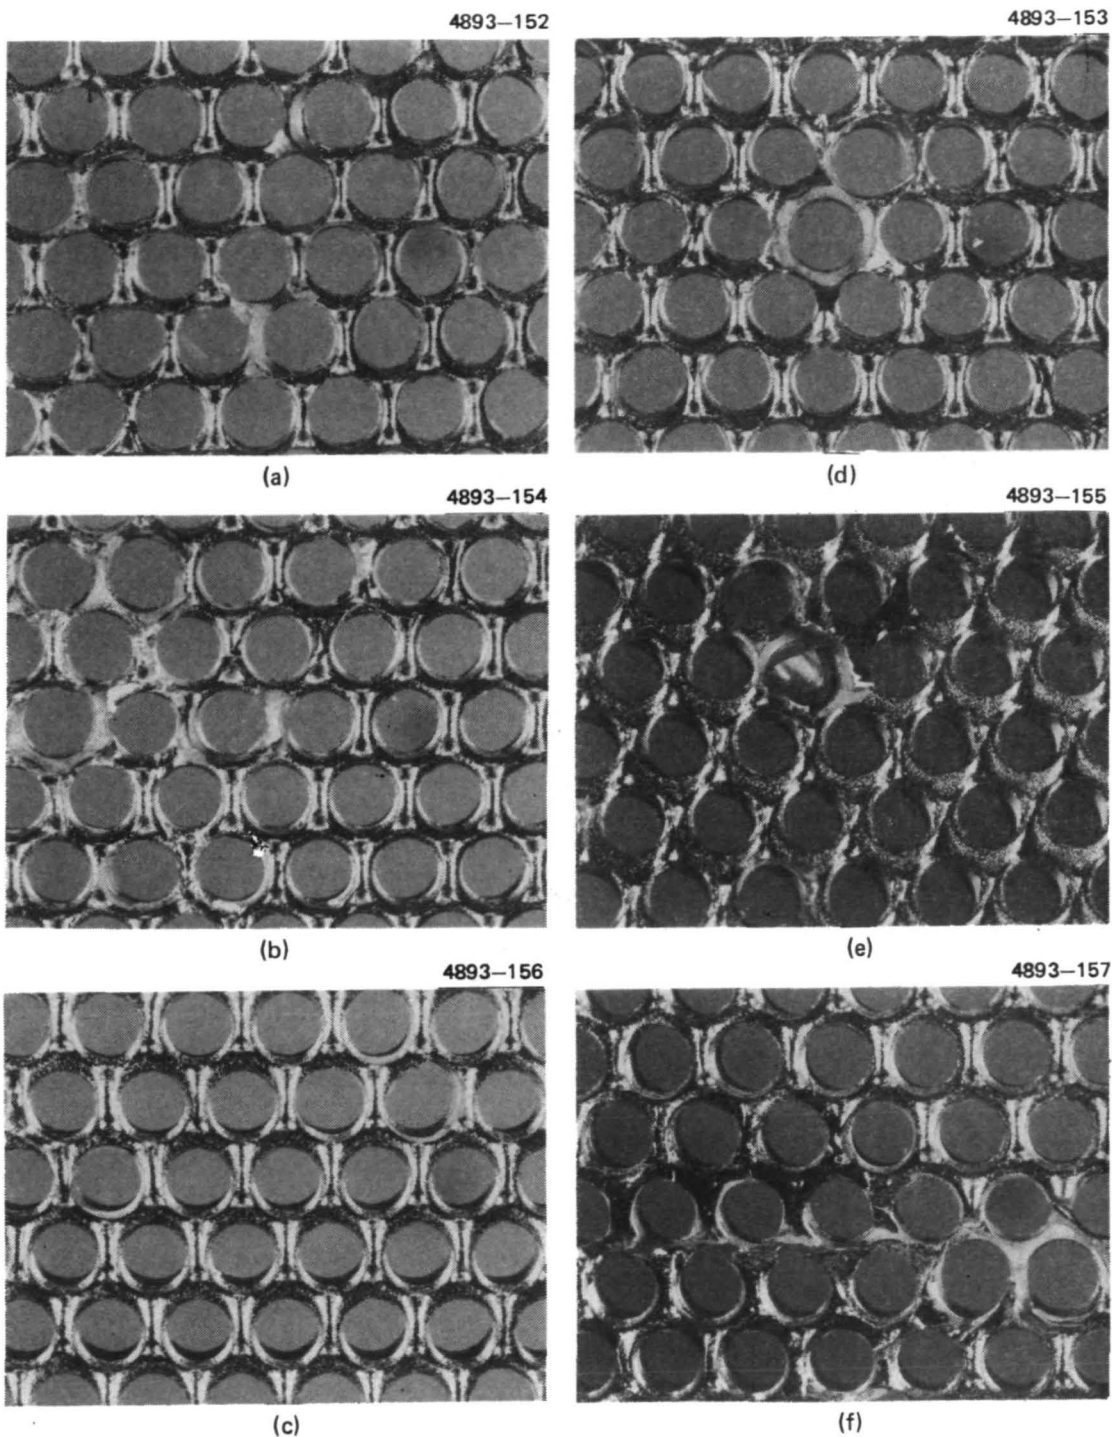
Some selected areas of damage are shown magnified in Fig. A-68. Note that in the views shown as (b) and (f), some webs of material between the apertures have been cut through completely by beam ions. View (e) shows a flake lodged in the electrodes and the resultant damage. Views (a), (b), and (c) illustrate the change in orientation of the charge exchange erosion patterns that can be seen as a function of thruster radius. The orientation of these photographs places the center of the electrode at the top of the page and view (a) is nearest the center, while view (c) is nearest the edge. It is apparent that the erosion is deepest near the electrode center, view (a), and that the erosion pattern is centered on and symmetric with the aperture pattern. Nearer the edge, as in Fig. A-68(c), the erosion is less and the pattern is shifted towards the grid center. This offset in the erosion pattern occurs because the beamlets formed at the edge apertures are by grid design deflected radially inward to counteract the divergent effect introduced by grid curvature and therefore the charge exchange ions are also focused towards the grid center.

Figure A-68. Selected areas of downstream surface of accel electrode.
